DOT/FAA/AM-09/23
Office of Aerospace Medicine
Washington, DC 20591

Evaluation of the Effects of Hydrogen Peroxide on Common Aviation Structural Materials

December 2009

Final Report

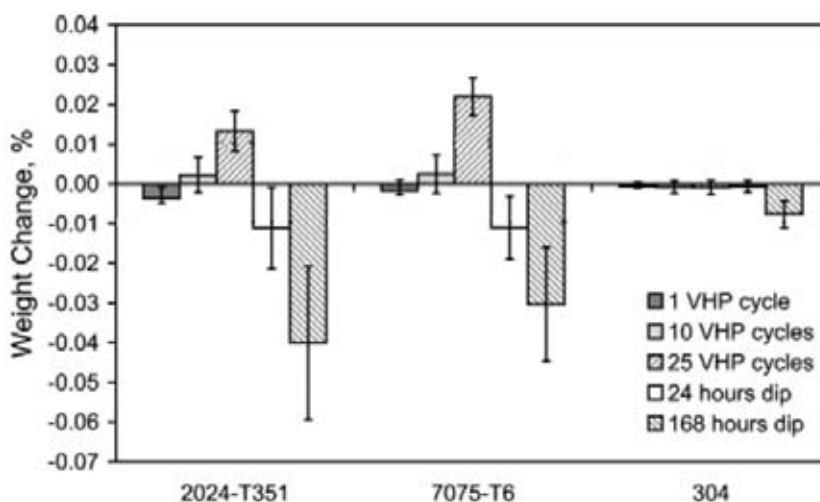
Figure 1. Metallic sample weight changes due to VHP and dip exposures. Error bars represent ± 1 standard deviation. (7)

No discernable differences were seen on the surfaces of the metallic samples after exposure to hydrogen peroxide (vapor or dip exposures). Specimens of 2024-T351, 7075-T6 and 304 stainless steel were weighed before and after hydrogen peroxide exposure, and the net weight change data are shown in Figure 1 (7). As seen in Figure 1, no statistically significant weight changes were observed for the stainless steel samples under any exposure condition. Both aluminum alloys exhibited a slight, but measurable weight gain after 25 VHP cycles (0.01-0.02%) suggesting a modest amount of superficial oxidation. Some weight loss (0.03-0.04%) was seen for the aluminum alloys after dip exposure to the 35% hydrogen peroxide liquid. Gale et al. (7) note that although the overall surface composition of the samples was not modified by the liquid hydrogen

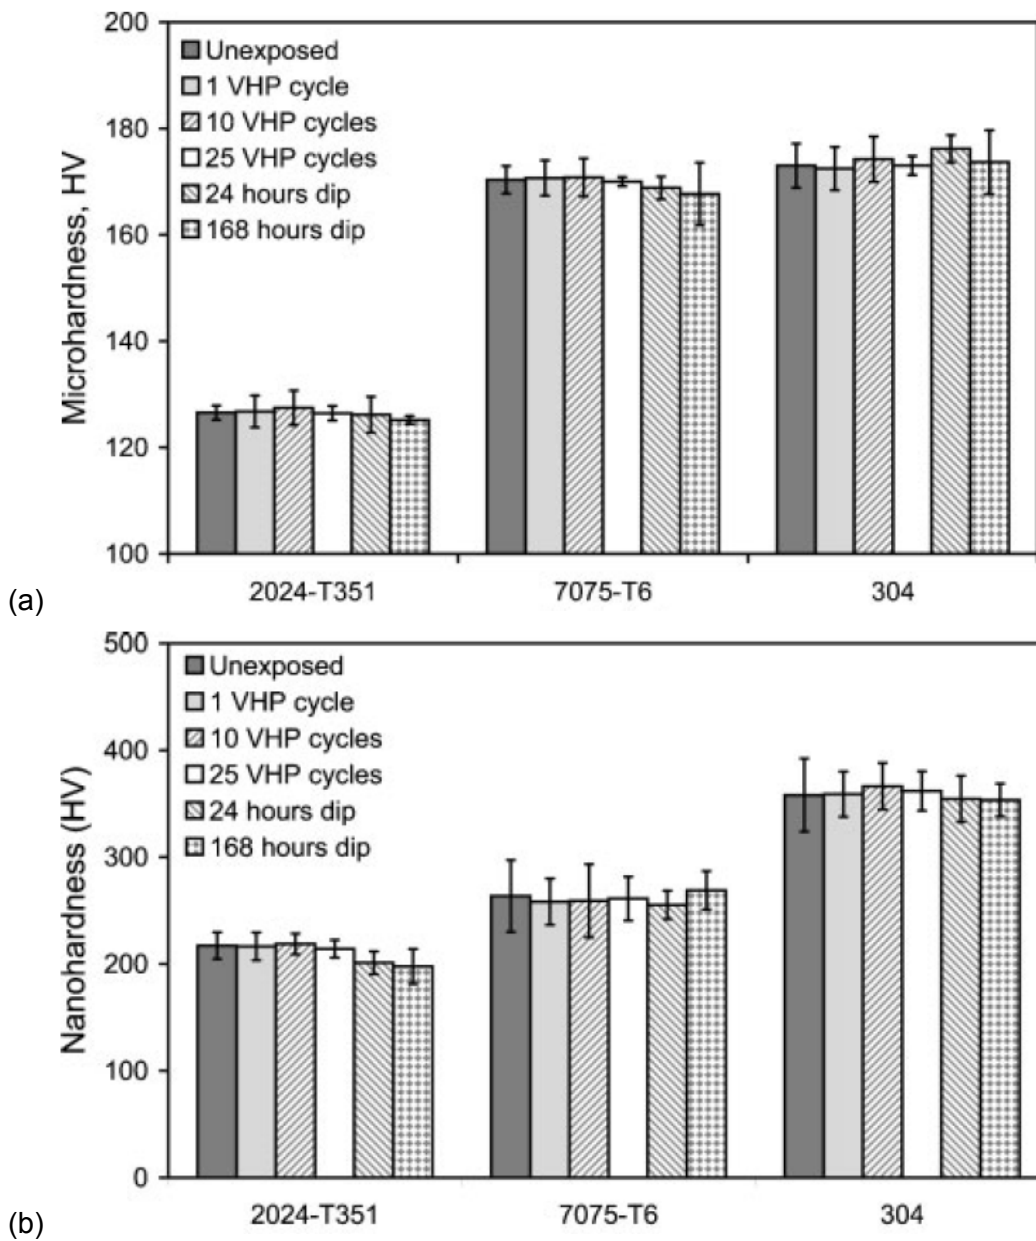
Figure 2. (a) Sample microhardness changes due to VHP and dip exposures.

(b) Sample nanohardness changes due to VHP and dip exposures.

Error bars represent ± 1 standard deviation. (7)

Surface hardness data are shown in Figures 2a and 2b. No changes in surface hardness using the Vickers measurement (Figure 2a) or the nanoindenter (Figure 2b) were seen for any of the alloys or hydrogen peroxide exposure conditions except for some slight but statistically significant softening observed in the nanohardness data of the 2024-T351 dip-tested samples.

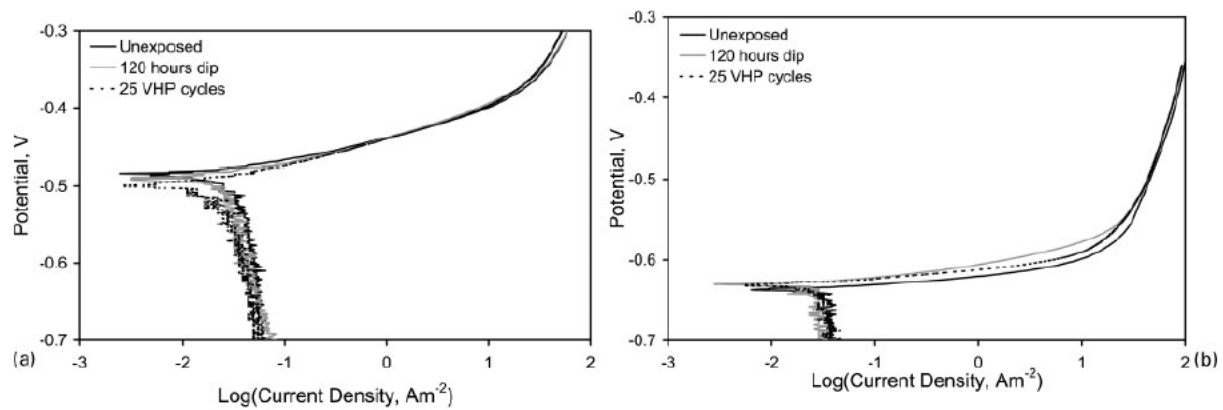
Figure 3. Cyclic voltammetry in 0.1M NaCl solution and Ag-AgCl reference electrode.

(a) 2024-T351, (b) 7075-T6. (7)

Cyclic voltammetry corrosion results are shown in Figure 3 for the 2024-T351 and the 7075-T6 aluminum samples. The potential of -0.5V exhibited by the 2024-T351 aluminum alloy agreed with literature data for samples tested under the same conditions but without prior exposure to hydrogen peroxide.(8) The shapes of the curves shown in Figure 3 were not significantly influenced by any of the hydrogen peroxide exposures, and the corrosion behavior of the alloys appears to have been unaffected by any of the hydrogen peroxide exposures.

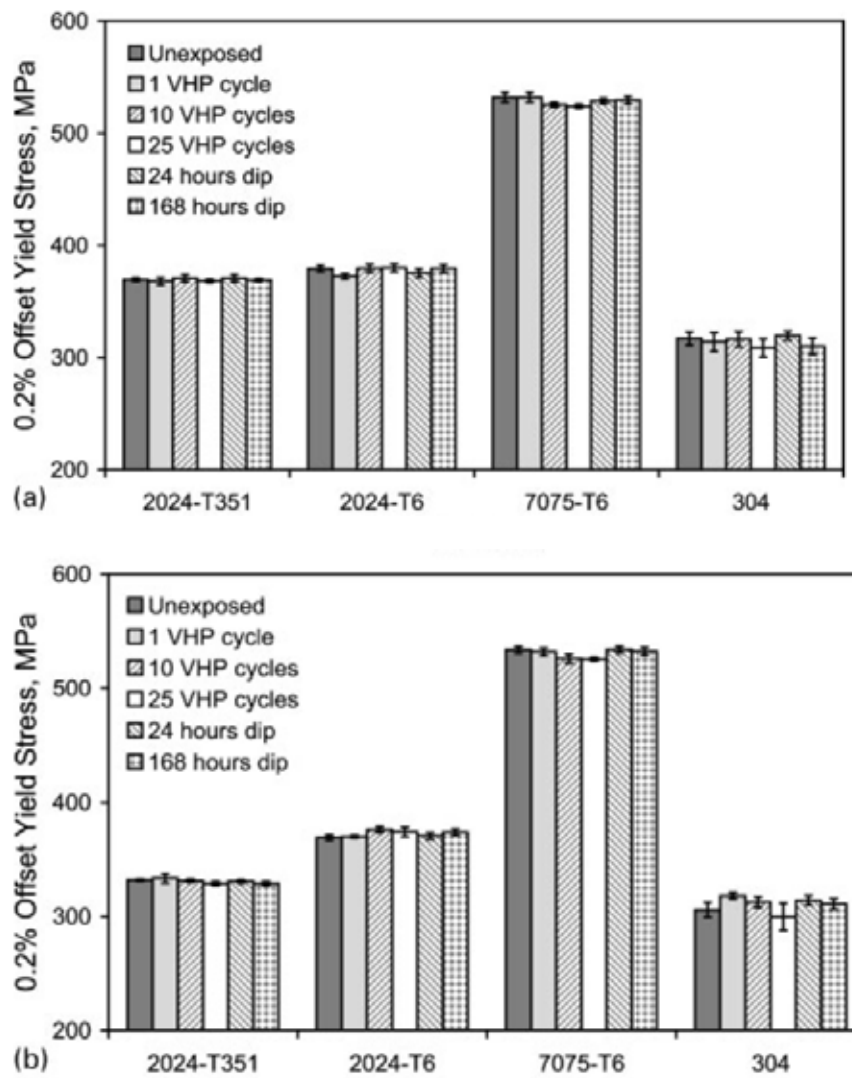
Figure 4. Effect of hydrogen peroxide exposure on the 0.2% offset yield strength of the alloys indicated.

Sample orientation: (a) longitudinal (b) transverse

Figures 4, 5, and 6 show the tensile data of the various metallic samples after the indicated exposures to vapor phase or liquid phase hydrogen peroxide. Tensile samples were taken from the sheet materials in either the longitudinal orientation or the transverse orientation. Examination of the tensile data of the aluminum alloys did not reveal any statistically significant effects of the hydrogen peroxide exposures (vapor or dip). Other than a slight decrease in the measured % elongation to failure of the transverse samples of the annealed 304 stainless steel (for reasons presently unclear), the 304 samples also did not exhibit any statistically significant affects of the hydrogen peroxide exposures.

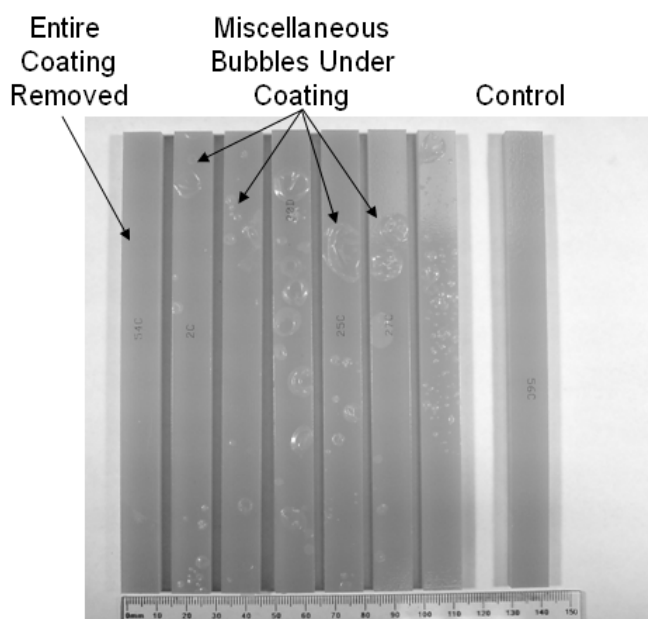
Figure 7. Various glass fiber/epoxy FR4 printed circuit board composite samples after 168 hr exposure to 35% liquid hydrogen peroxide. Control sample was not exposed.

No visual differences were seen on the surfaces of either the CF/E, CF/GF-E, or uncoated FR4 samples after exposure to hydrogen peroxide (vapor or dip exposures). However, exposing the FR4 samples with the conformal coating to 35% liquid hydrogen peroxide for 168 hr caused significant blistering and loss of the acrylic coating, as shown in Figure 7. The net changes in weight for the various samples are shown in Figure 8. The carbon fiber/epoxy material exhibited no significant weight change after 10 VHP exposures but approximately 0.065 % increase in weight after the 168 hr liquid exposure followed by vacuum drying. The carbon fiberglass fiber/epoxy material exhibited increases in weight after vacuum drying of about 0.015% after 10 VHP exposures and 0.035% after the 168 hr liquid exposure.

The FR4 samples (coated and uncoated, longitudinal or transverse orientations) displayed negligible weight changes after a single VHP cycle but about 0.02% decrease in weight after 10 VHP cycles. The 168-hr dip exposures caused increases in weight of about 0.07% for the uncoated samples and approximately 0.03% for the coated (transverse orientation) samples, indicating perhaps either some residual absorbed liquid or some slight oxidation of the samples. The dip exposures of the longitudinally oriented samples shown in Figure 7 caused highly variable weight losses consistent with the blistering of the conformal coating, as shown in Figure 7.

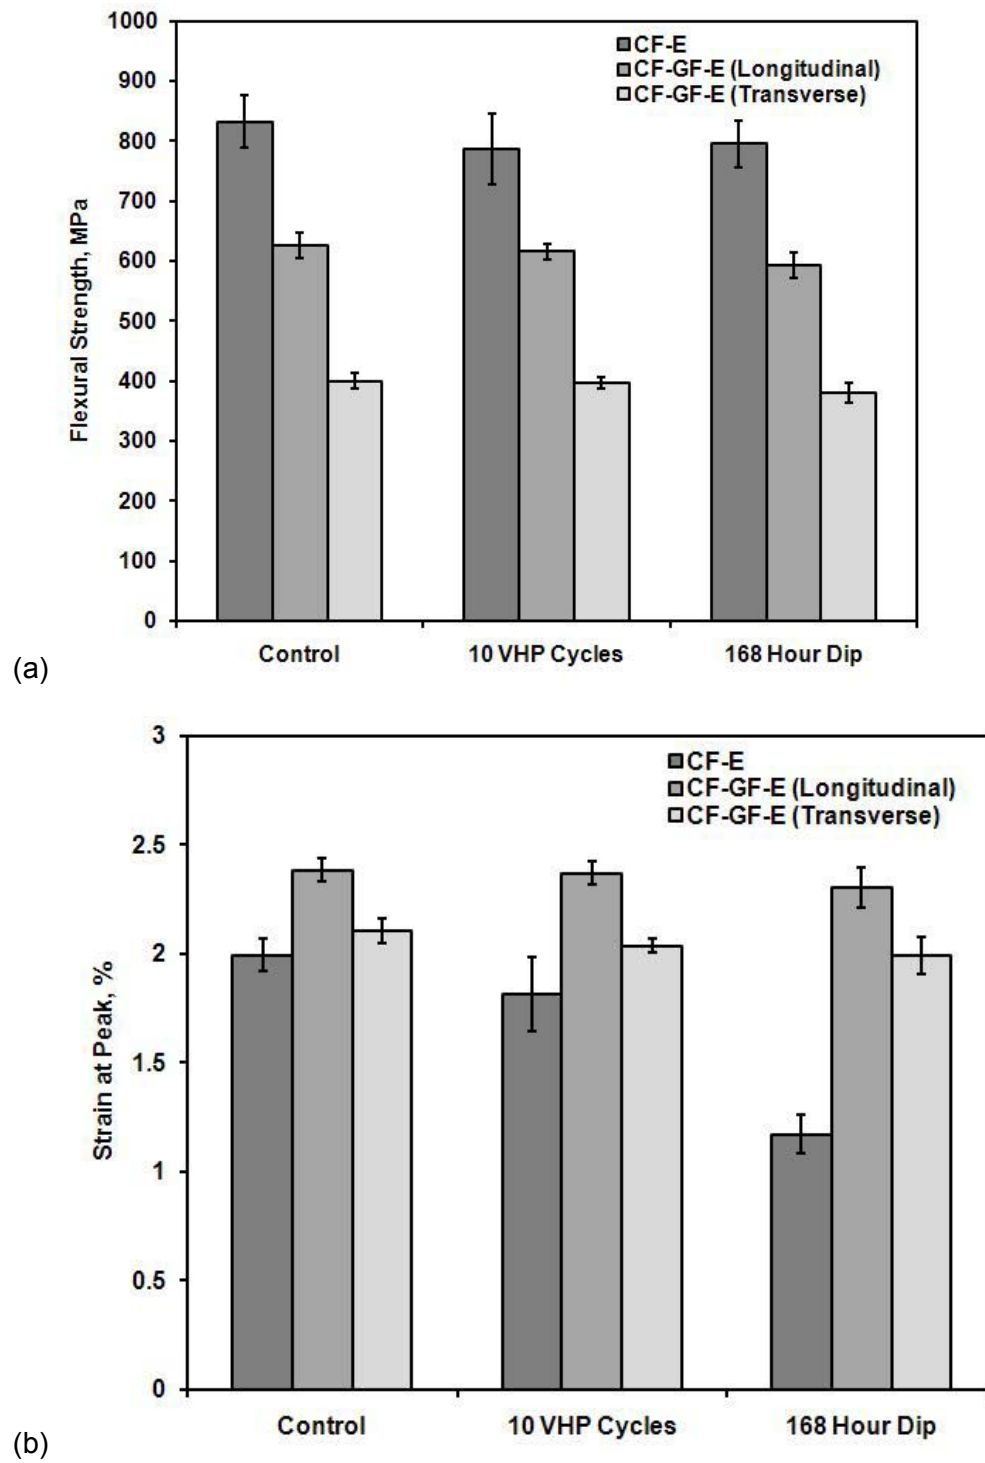
Figure 9. Effect of hydrogen peroxide exposure on the carbon and glass fiber - epoxy structural composites. (a) flexural strength, (b) strain at peak load Error bars represent ± 1 standard deviation.

The flexural properties of the carbon and glass fiber/epoxy structural composites are shown in Figure 9. The carbon fiber/epoxy material exhibited no significant change in flexural strength or strain at peak load after 10 VHP cycles. However, statistically significant decreases in flexural strength and especially strain at peak load were exhibited after 168 hr dip exposures to 35% hydrogen peroxide. The failure modes of these samples were characterized by increased amounts of delamination of the reinforcement fabrics, as shown in Figure 10. The decrease in peak load strain is particularly troubling, as it indicates increased brittleness of this material. This tendency to delaminate and the blistering tendency of the acrylic coating of the FR4 materials may be the result of diffusion of H₂O₂ molecules to the interfaces of these materials and then generation of microbubbles of either oxygen or water vapor, or both, during decomposition of the hydrogen peroxide.

Although the transverse direction flexural strength and strain at peak load of the carbon fiberglass fiber/epoxy material were lower than those measured in the longitudinal direction, as seen in Figure 9(b), no

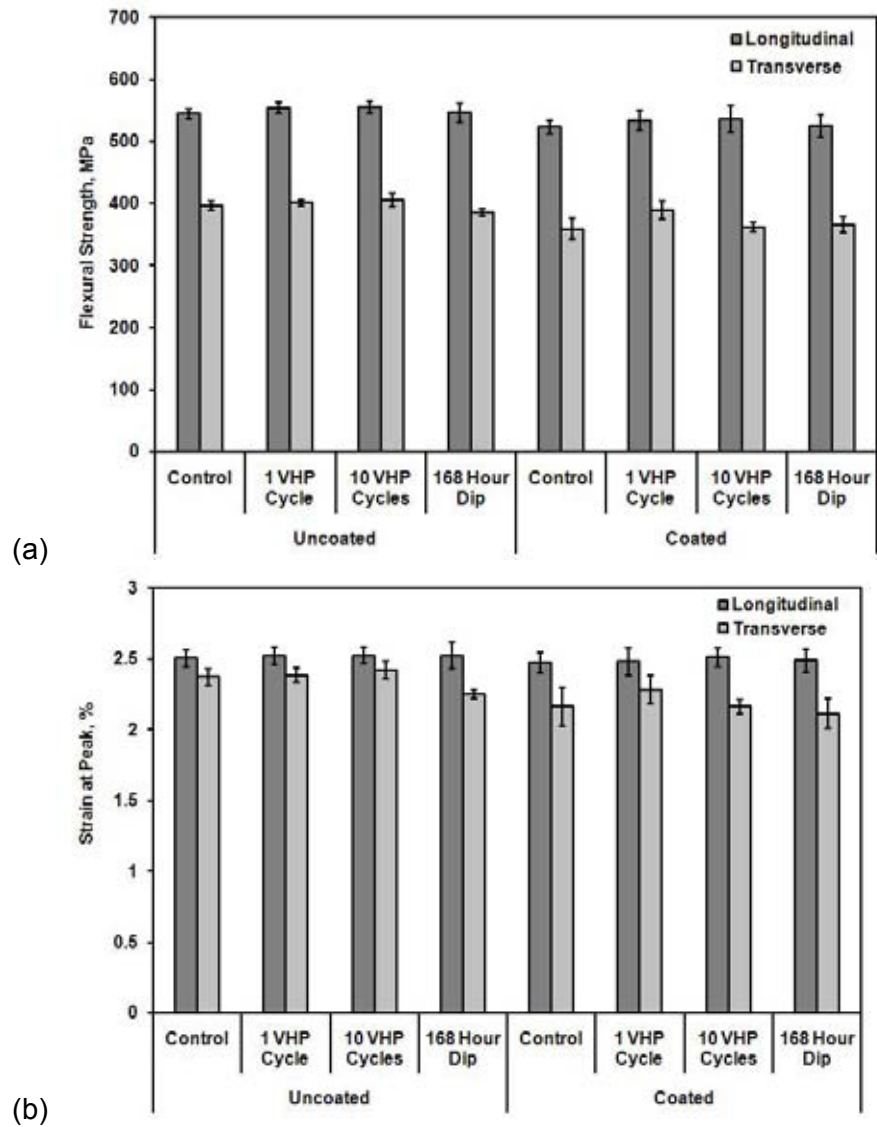
Figure 11. Effect of hydrogen peroxide exposure on the flexural properties of the glass fiber/epoxy FR4 printed circuit board composite. (a) flexural strength, (b) strain at peak load. Error bars represent ± 1 standard deviation.

The flexural properties of the FR4 printed circuit board composites are shown in Figure 11. As noted above for the carbon fiberglass fiber/epoxy material, the flexural properties measured in the transverse direction were consistently lower than those measured in the longitudinal direction. No statistically significant differences were found in either the flexural strength or the strain at peak load as a result of FR4 exposure to hydrogen peroxide vapor or liquid, except for slight degradation of the FR4 transverse sample strain at peak load after 168 hr dip exposures to 35% hydrogen peroxide.

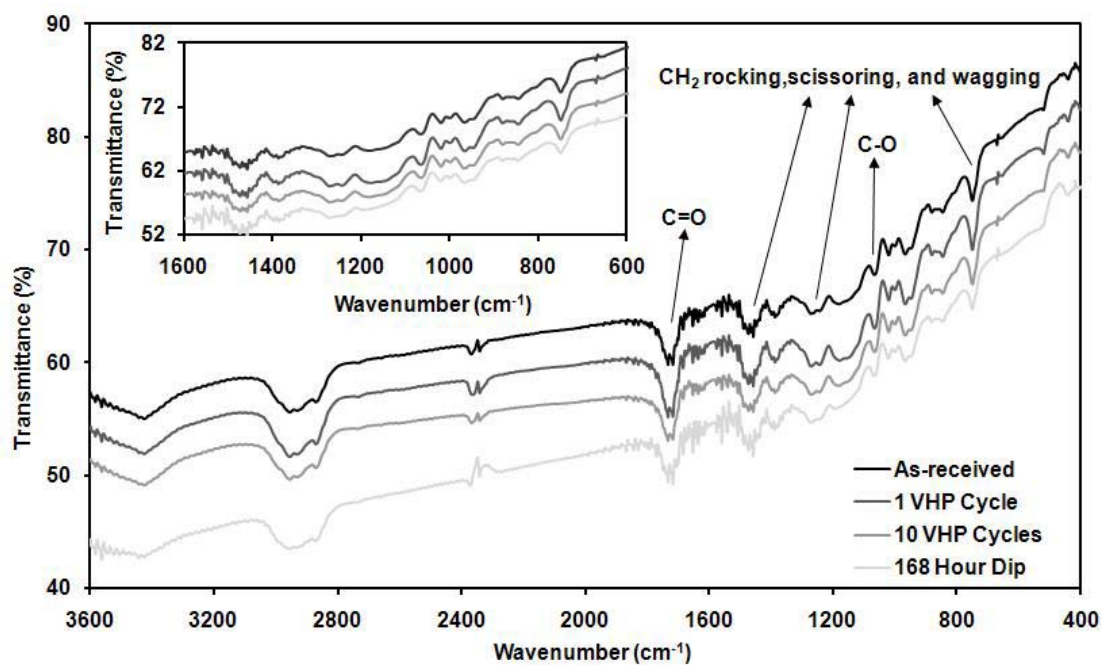
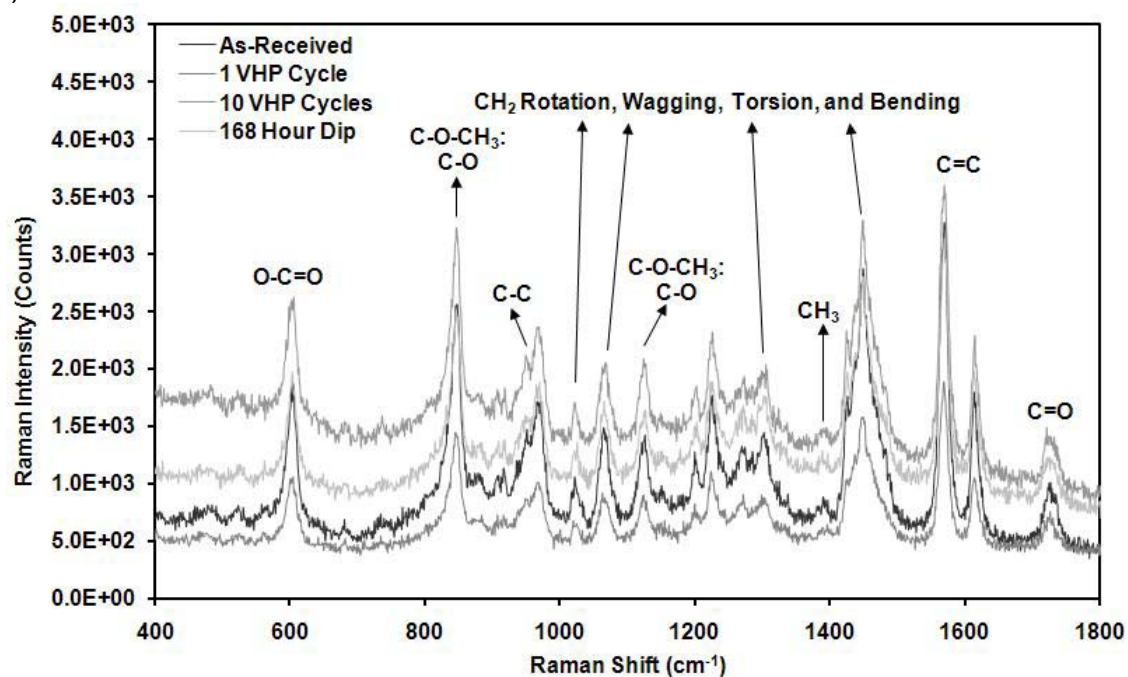
Figure 12. (a) FTIR and (b) Raman spectroscopy of the acrylic conformal coating from the glass fiber/epoxy FR4 printed circuit board composite.

FTIR and Raman spectroscopy were used to examine potential changes due to hydrogen peroxide exposure on the chemical structure of the acrylic conformal coating on the glass fiber/epoxy FR4 printed circuit board composite (see Figure 12), as well as the epoxy matrices of the carbon fiber/epoxy composite and the FR4 material (see Figure 13). The analyses showed no detectable compositional-based changes due to hydrogen peroxide exposures. The usual characteristic bands observed in the spectra are noted in Figures 12 and 13.

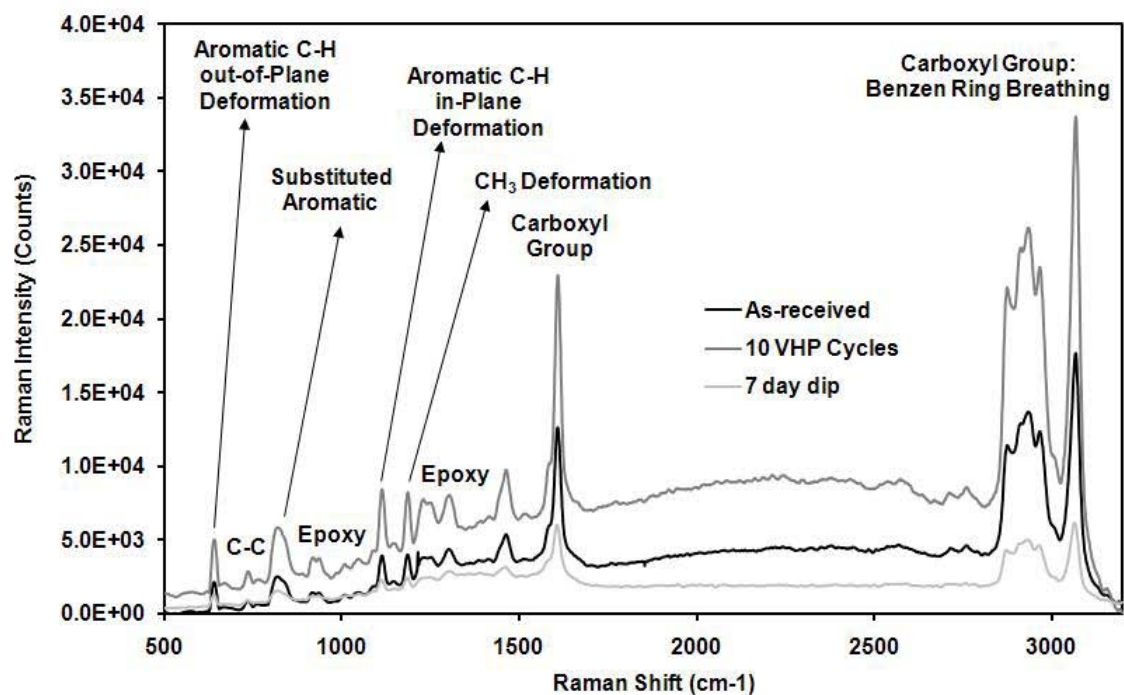
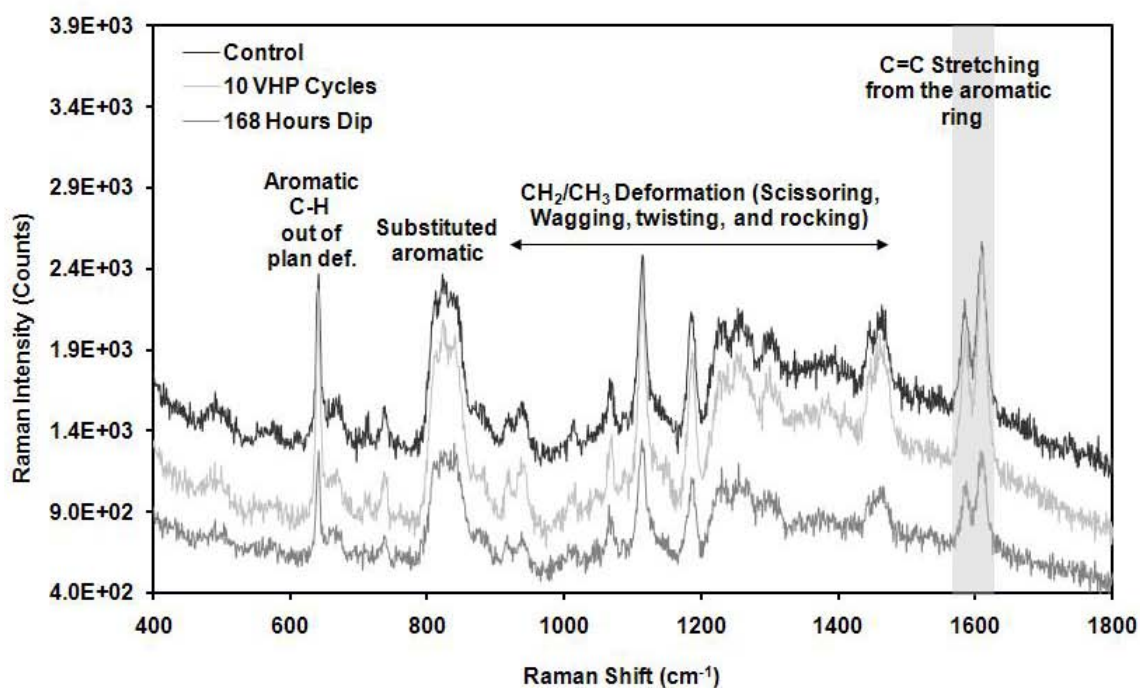
Figure 13. Raman spectroscopy of the epoxy matrix from the (a) carbon fiber/epoxy structural composite and (b) glass fiber/epoxy FR4 printed circuit board composite.
